**Flood Control Project Maintenance
Levee Inspections**

Fall 2014 Levee Maintenance Deficiency Summary Report

Reclamation District No. 0001 Union Island

Levee Inspection Report By Mile - Fall 2014

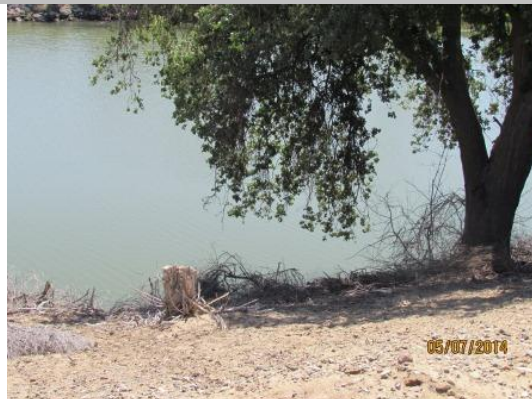
Photo 1 of 1 : FA_2014_RD0001_23_12_20141001_00009.jpg

View of the tree stump on the waterside levee slope.

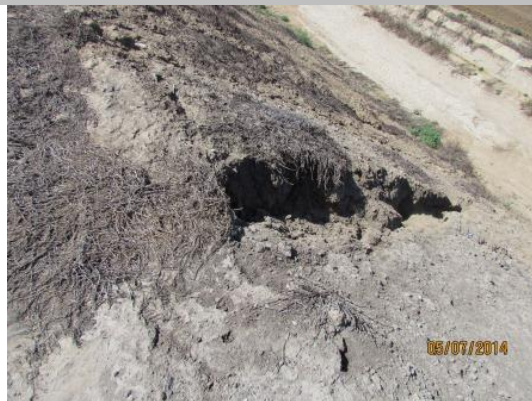
Photo 1 of 1 : FA_2014_RD0001_23_5_20141001_00004.jpg

View of the erosion on the landside levee slope.

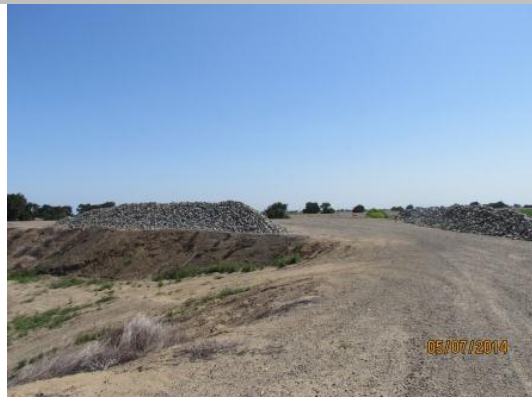
Photo 1 of 1 : FA_2014_RD0001_23_11_20141001_00008.jpg

View of the riprap stockpiled on the levee crown.

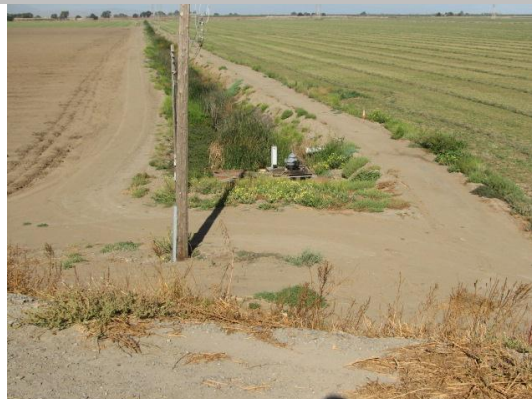
Photo 1 of 1 : FA_2014_RD0001_23_7_20141001_00005.jpg

LM Start	0.39	Rating **	A/W	Issue No.	7
LM End	0.39	Issue Type +	En	Location *	WS
Category	Earthen Levee			GPS Latitude/Longitude	
				Start	End
Item	Encroachments			37.819651 °	37.819651 °
				-121.380467 °	-121.380467 °
DWR ID	DWR_RD0001_01_s_2012_7				
Action/Comments					
Pipe Inspector Comments: Irrigation intake through levee crown.

View of the pipe through levee freeboard.

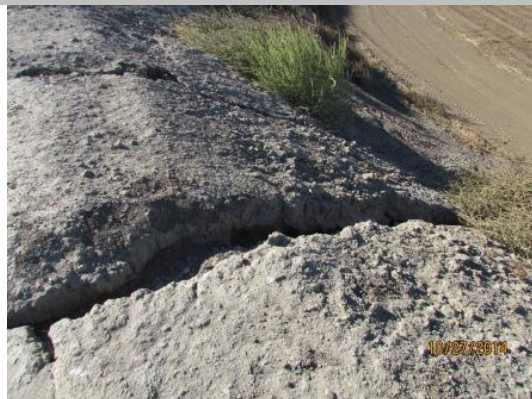
Photo 1 of 1 : FA_2014_RD0001_23_4_20141027_00018.jpg

View of the scour from surface runoff on the landside levee slope.

LM Start	0.50	Rating **	M	Issue No.	4
LM End	0.50	Issue Type +	Ma	Location *	LS
Category	Earthen Levee			GPS Latitude/Longitude	
				Start	End
Item	Slope Stability			37.818014 °	37.818014 °
				-121.379829 °	-121.379829 °
DWR ID	DWR_RD0001_01_f_2014_4				
Action/Comments					
Repair slope instability.

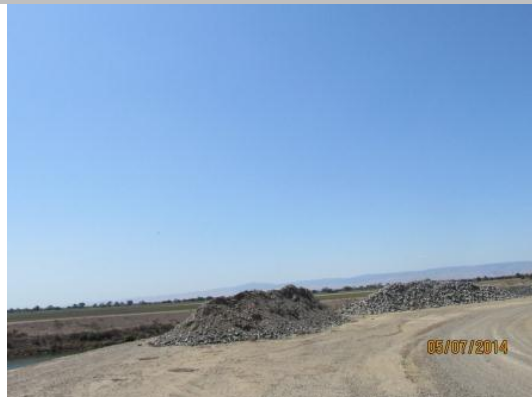
Photo 1 of 1 : FA_2014_RD0001_23_14_20141001_00010.jpg

LM Start	0.53	Rating **	M	Issue No.	14
LM End	0.53	Issue Type +	Ma	Location *	CR
Category	Earthen Levee			GPS Latitude/Longitude	
				Start	End
Item	Encroachments			37.817651 °	37.817651 °
				-121.379898 °	-121.379898 °
DWR ID	DWR_RD0001_01_s_2014_14				
Action/Comments					
Material Inspector Comments: Riprap stockpiled on levee crown.

View of the riprap stockpiled on the levee crown.

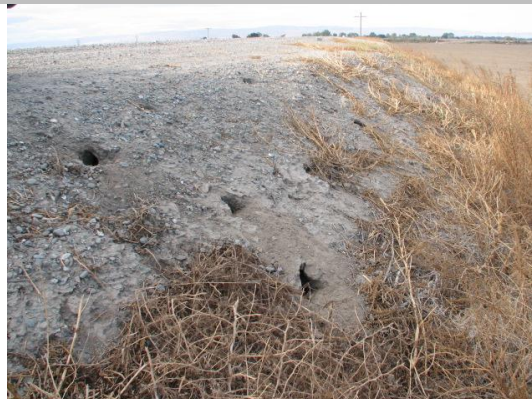
Photo 1 of 1 : FA_2014_RD0001_23_15_20141001_00011.jpg

Rodent holes on levee slope.

LM Start	0.66	Rating **	M	Issue No.	15
LM End	0.66	Issue Type +	Ma	Location *	LS
Category	Earthen Levee			GPS Latitude/Longitude	
				Start	End
Item	Animal Control			37.817249 °	37.817249 °
				-121.382026 °	-121.382026 °
DWR ID	DWR_RD0001_01_s_2012_15				
Action/Comments					
No rodents visible, but rodent burrows visible; need to backfill and compact or grout burrows.

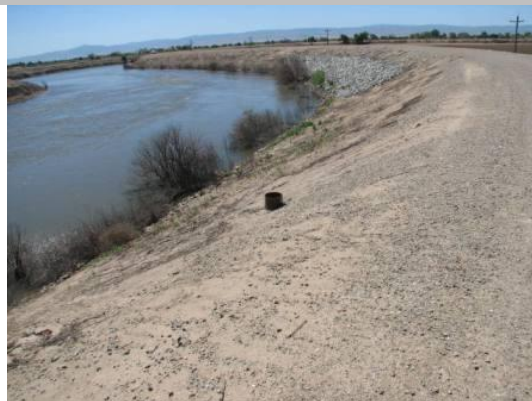
Photo 1 of 1 : FA_2014_RD0001_23_20_20141001_00014.jpg

LM Start	0.67	Rating **	A/W	Issue No.	20
LM End	0.67	Issue Type +	En	Location *	LS
Category	Earthen Levee			GPS Latitude/Longitude	
				Start	End
Item	Encroachments			37.817134 °	37.817134 °
				-121.382099 °	-121.382099 °
DWR ID	DWR_RD0001_01_s_2012_20				
Action/Comments					
Pipe					
Inspector Comments: Drainage discharge into Old River. No photo found from previous inspection. 04/26/2011 photo added.

04/26/2011 Discharge pipe in waterside slope.

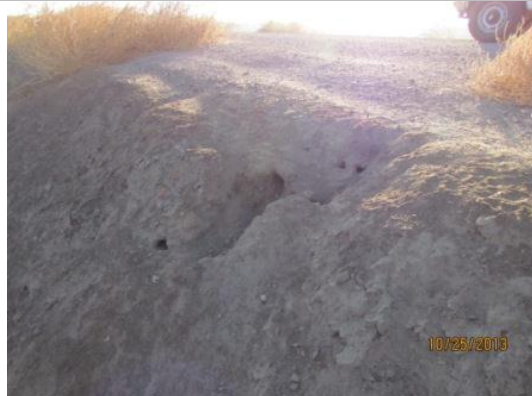
Photo 1 of 1 : FA_2014_RD0001_23_23_20141001_00015.jpg

View of the rodent burrow on the landside slope.

LM Start	1.14	Rating **	M	Issue No.	23
LM End	1.14	Issue Type +	Ma	Location *	LS
Category	Earthen Levee			GPS Latitude/Longitude	
				Start	End
Item	Animal Control			37.811775 °	37.811775 °
				-121.384764 °	-121.384764 °
DWR ID	DWR_RD0001_01_f_2013_23				
Action/Comments					
No rodents visible, but rodent burrows visible; need to backfill and compact or grout burrows.
